Inspection Report

Mine Name: Thomas Pit

Operator Name: Lakeview Rock Products, Inc.

Permit number: M/011/002

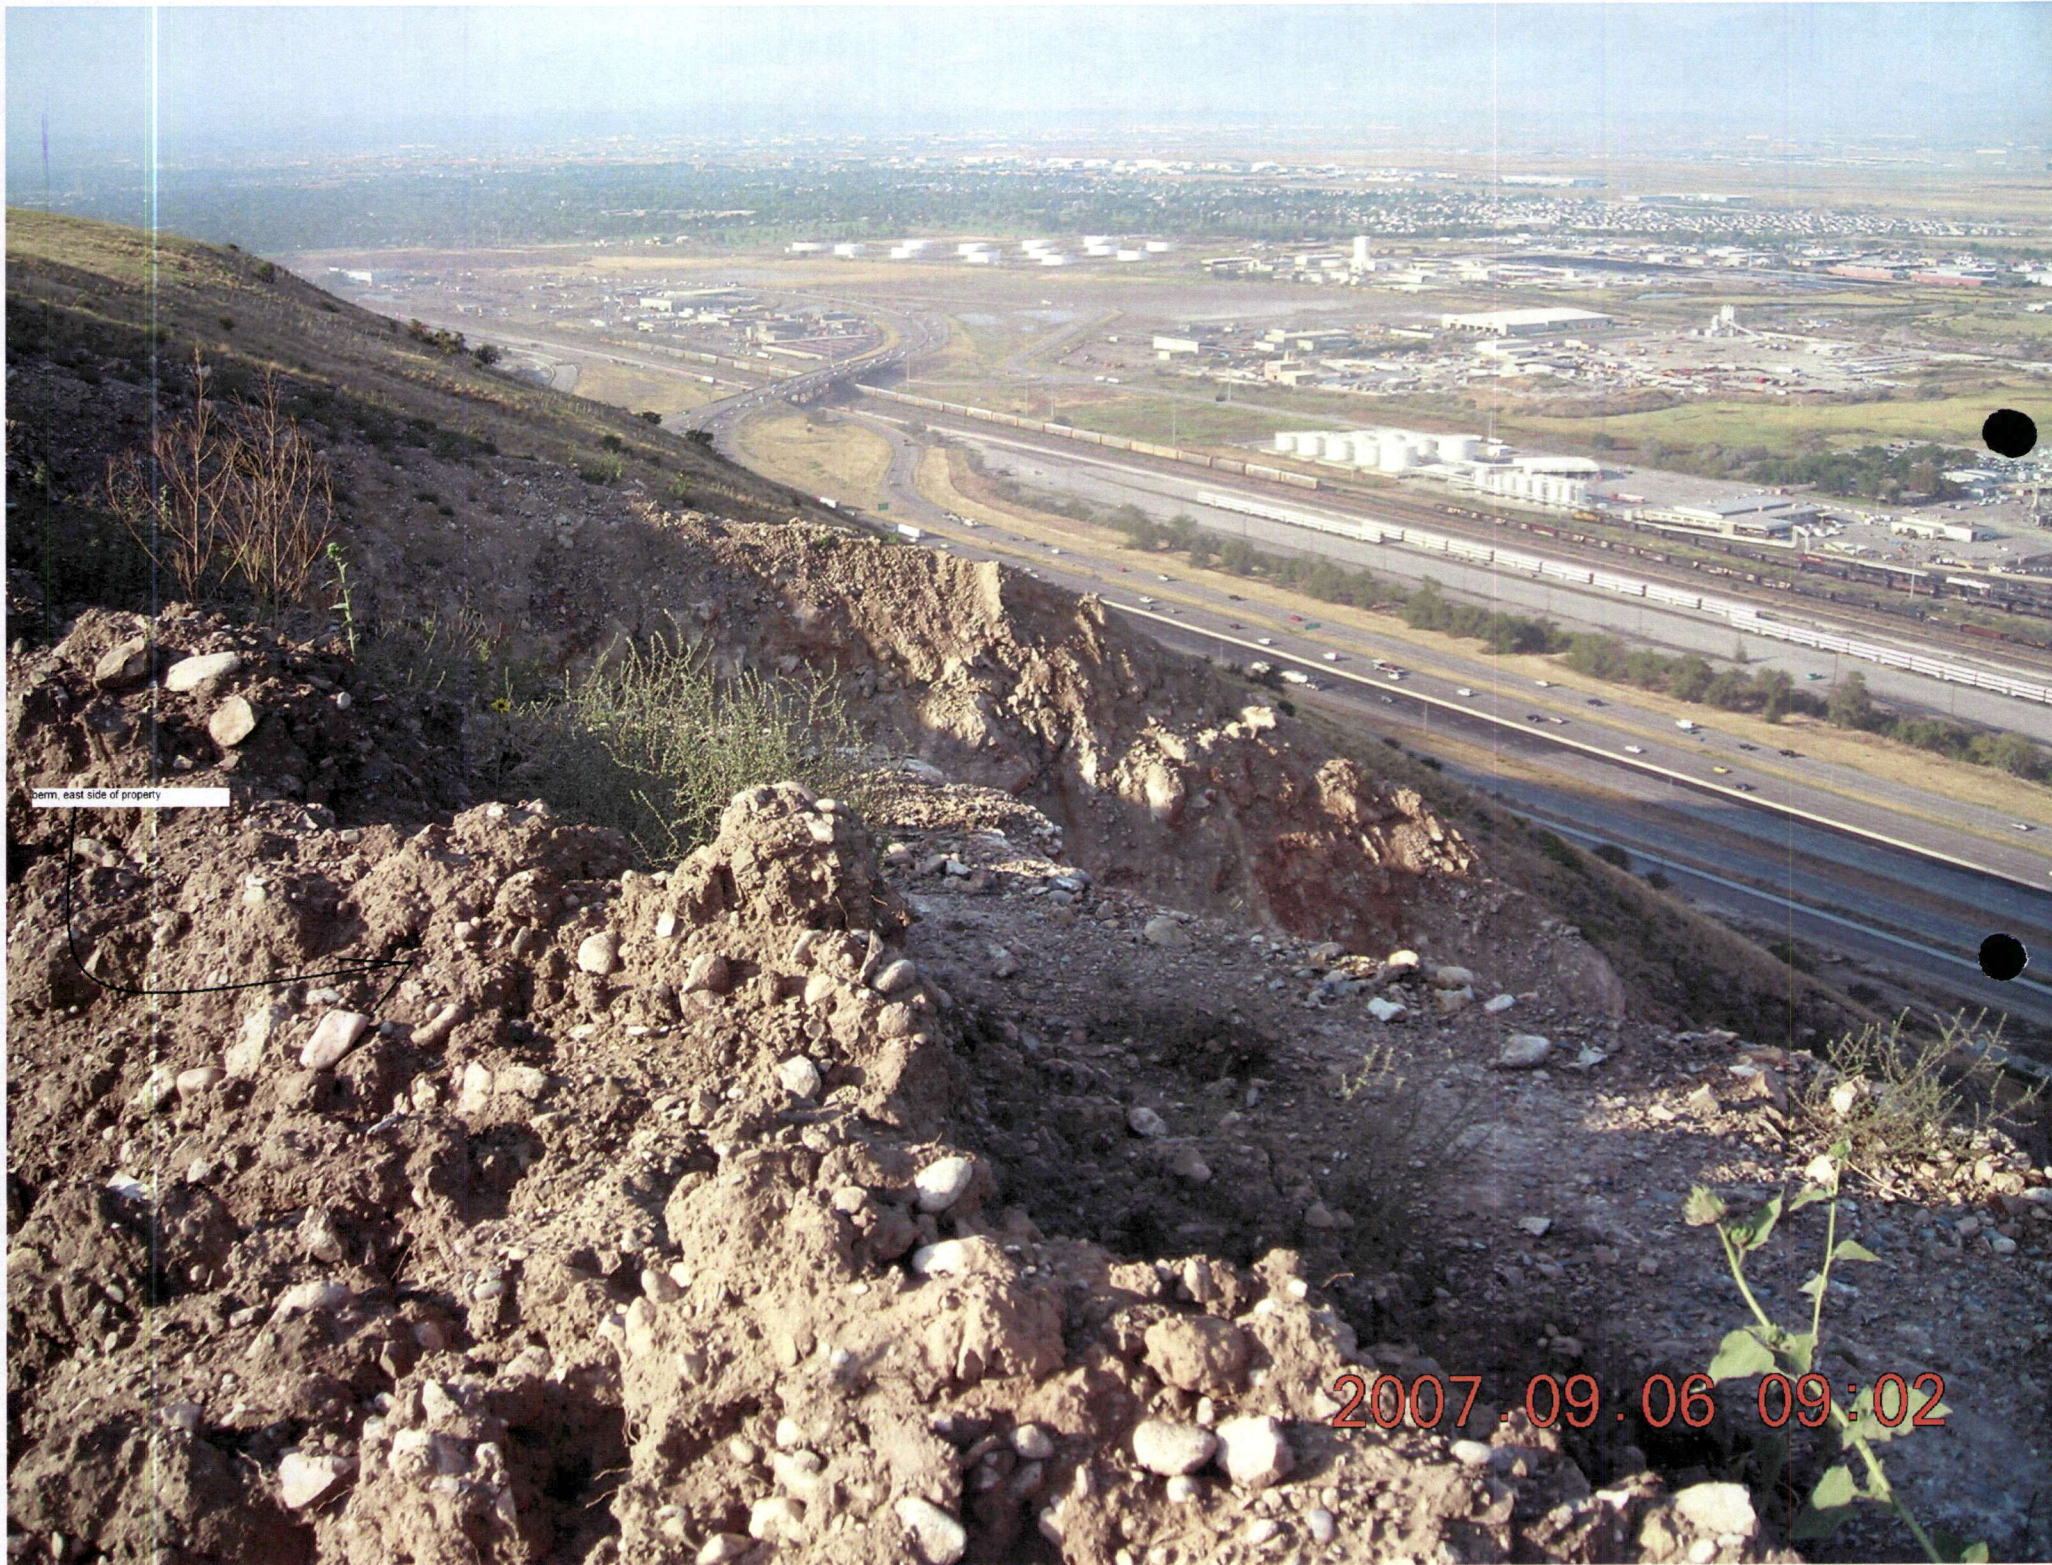
2007.09.06 09:02

berm, east side of property

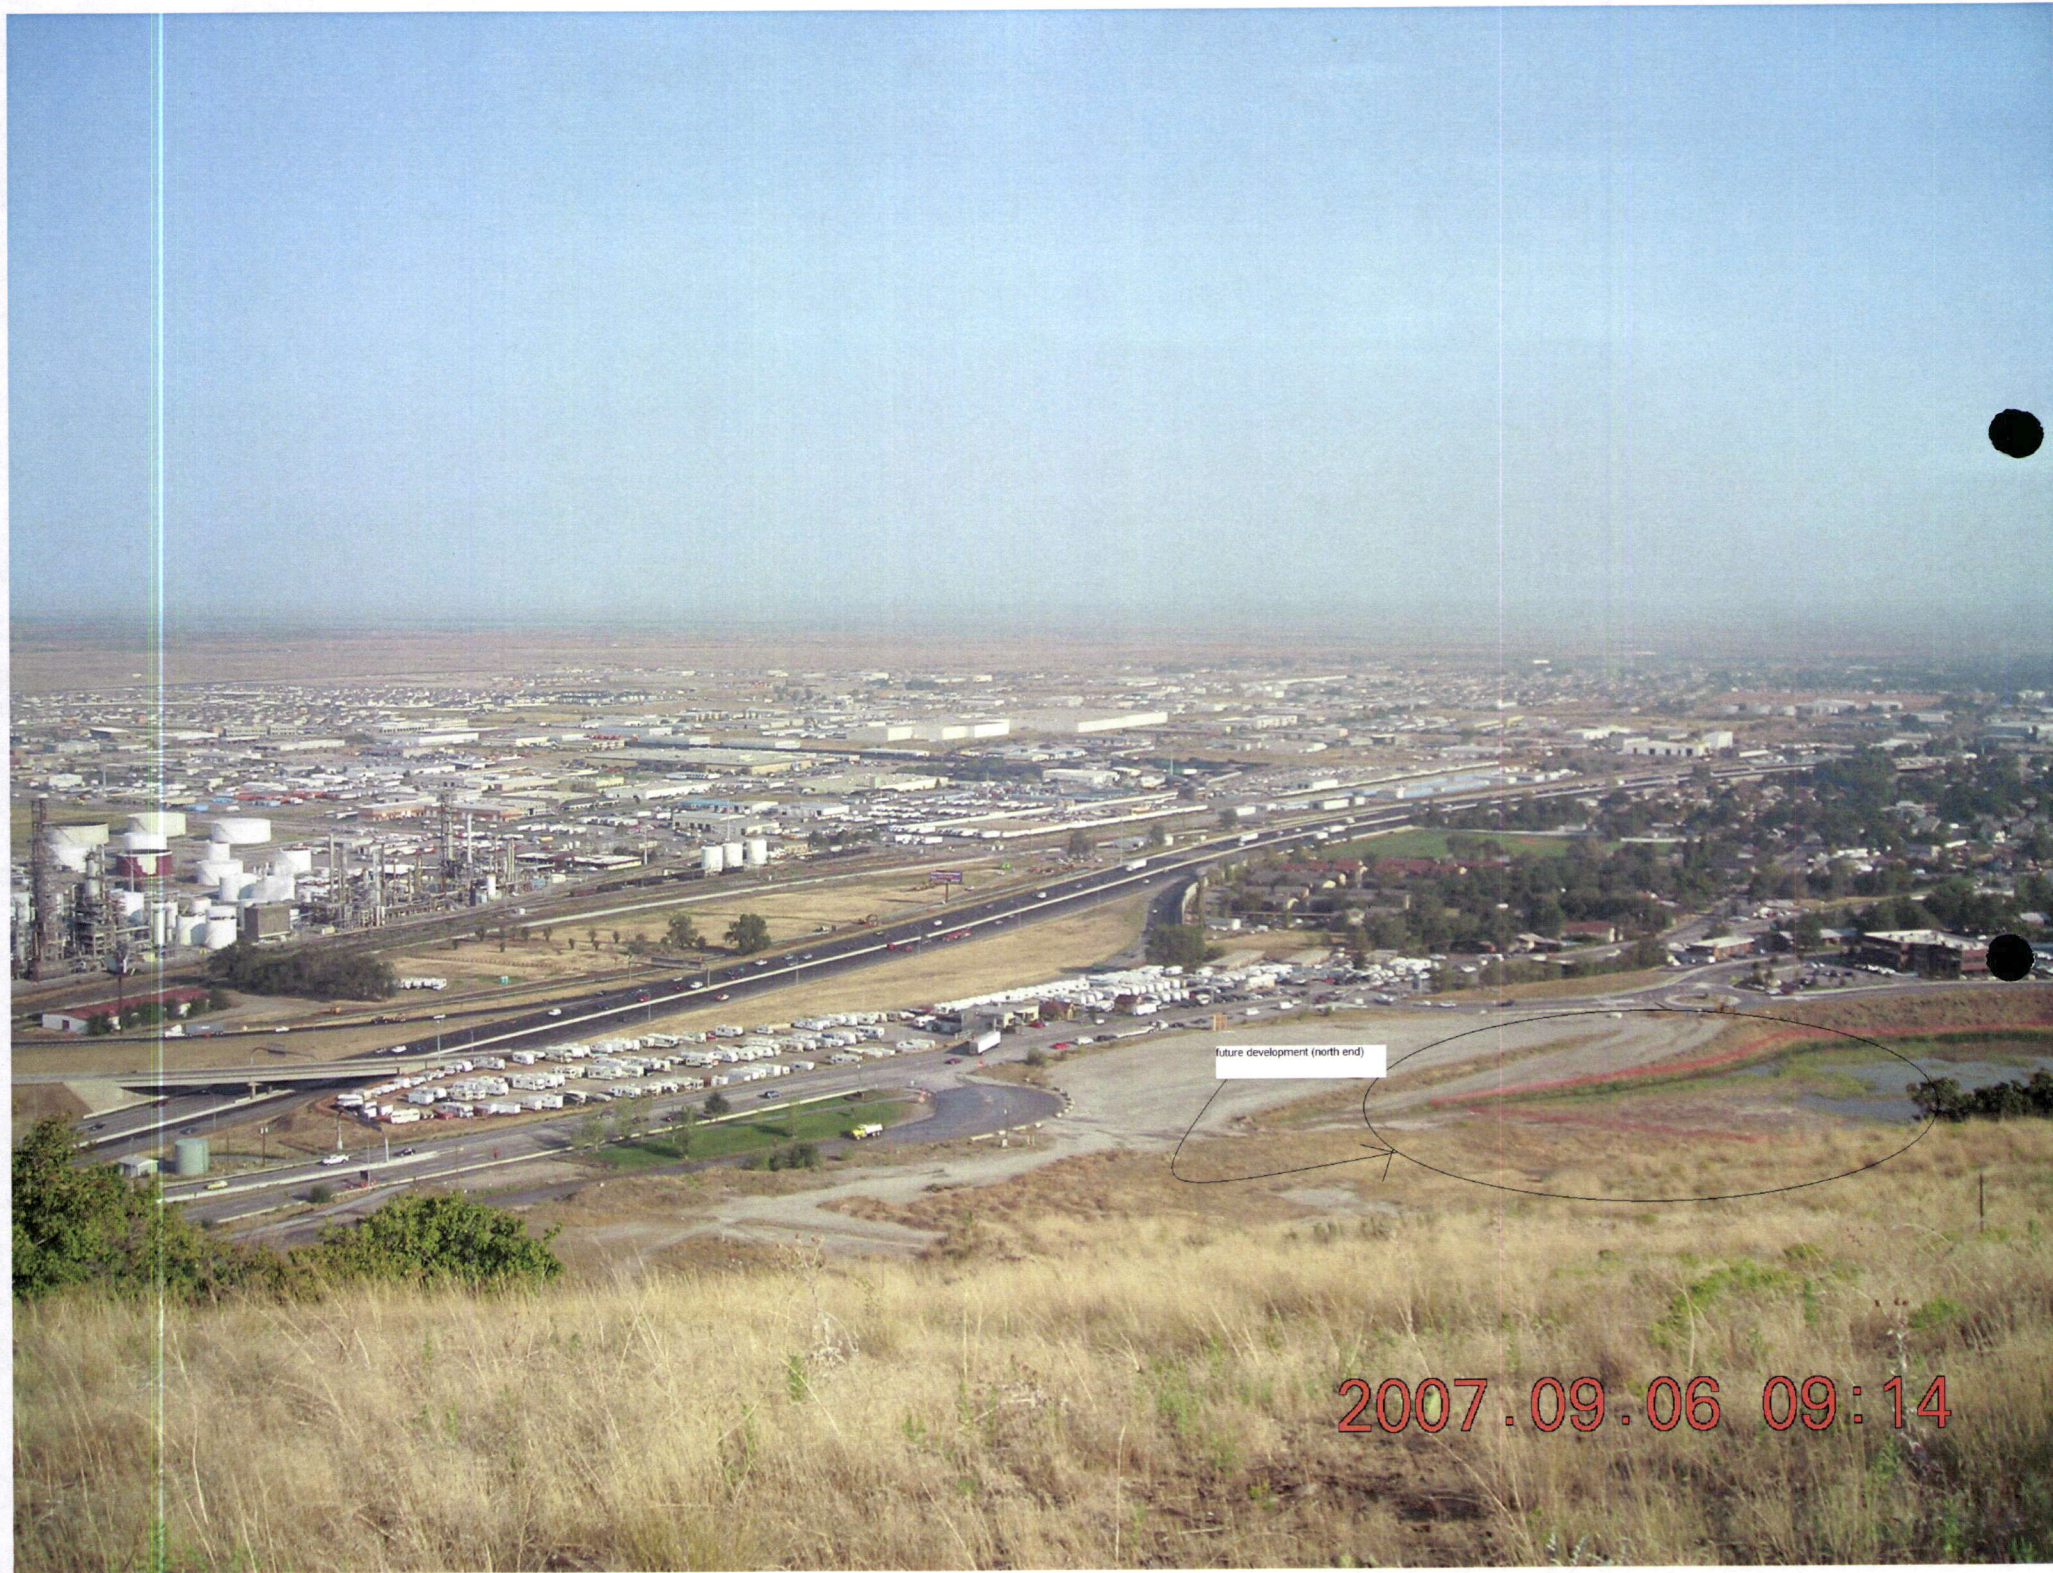
2007.09.06 09:14

future development (north end)

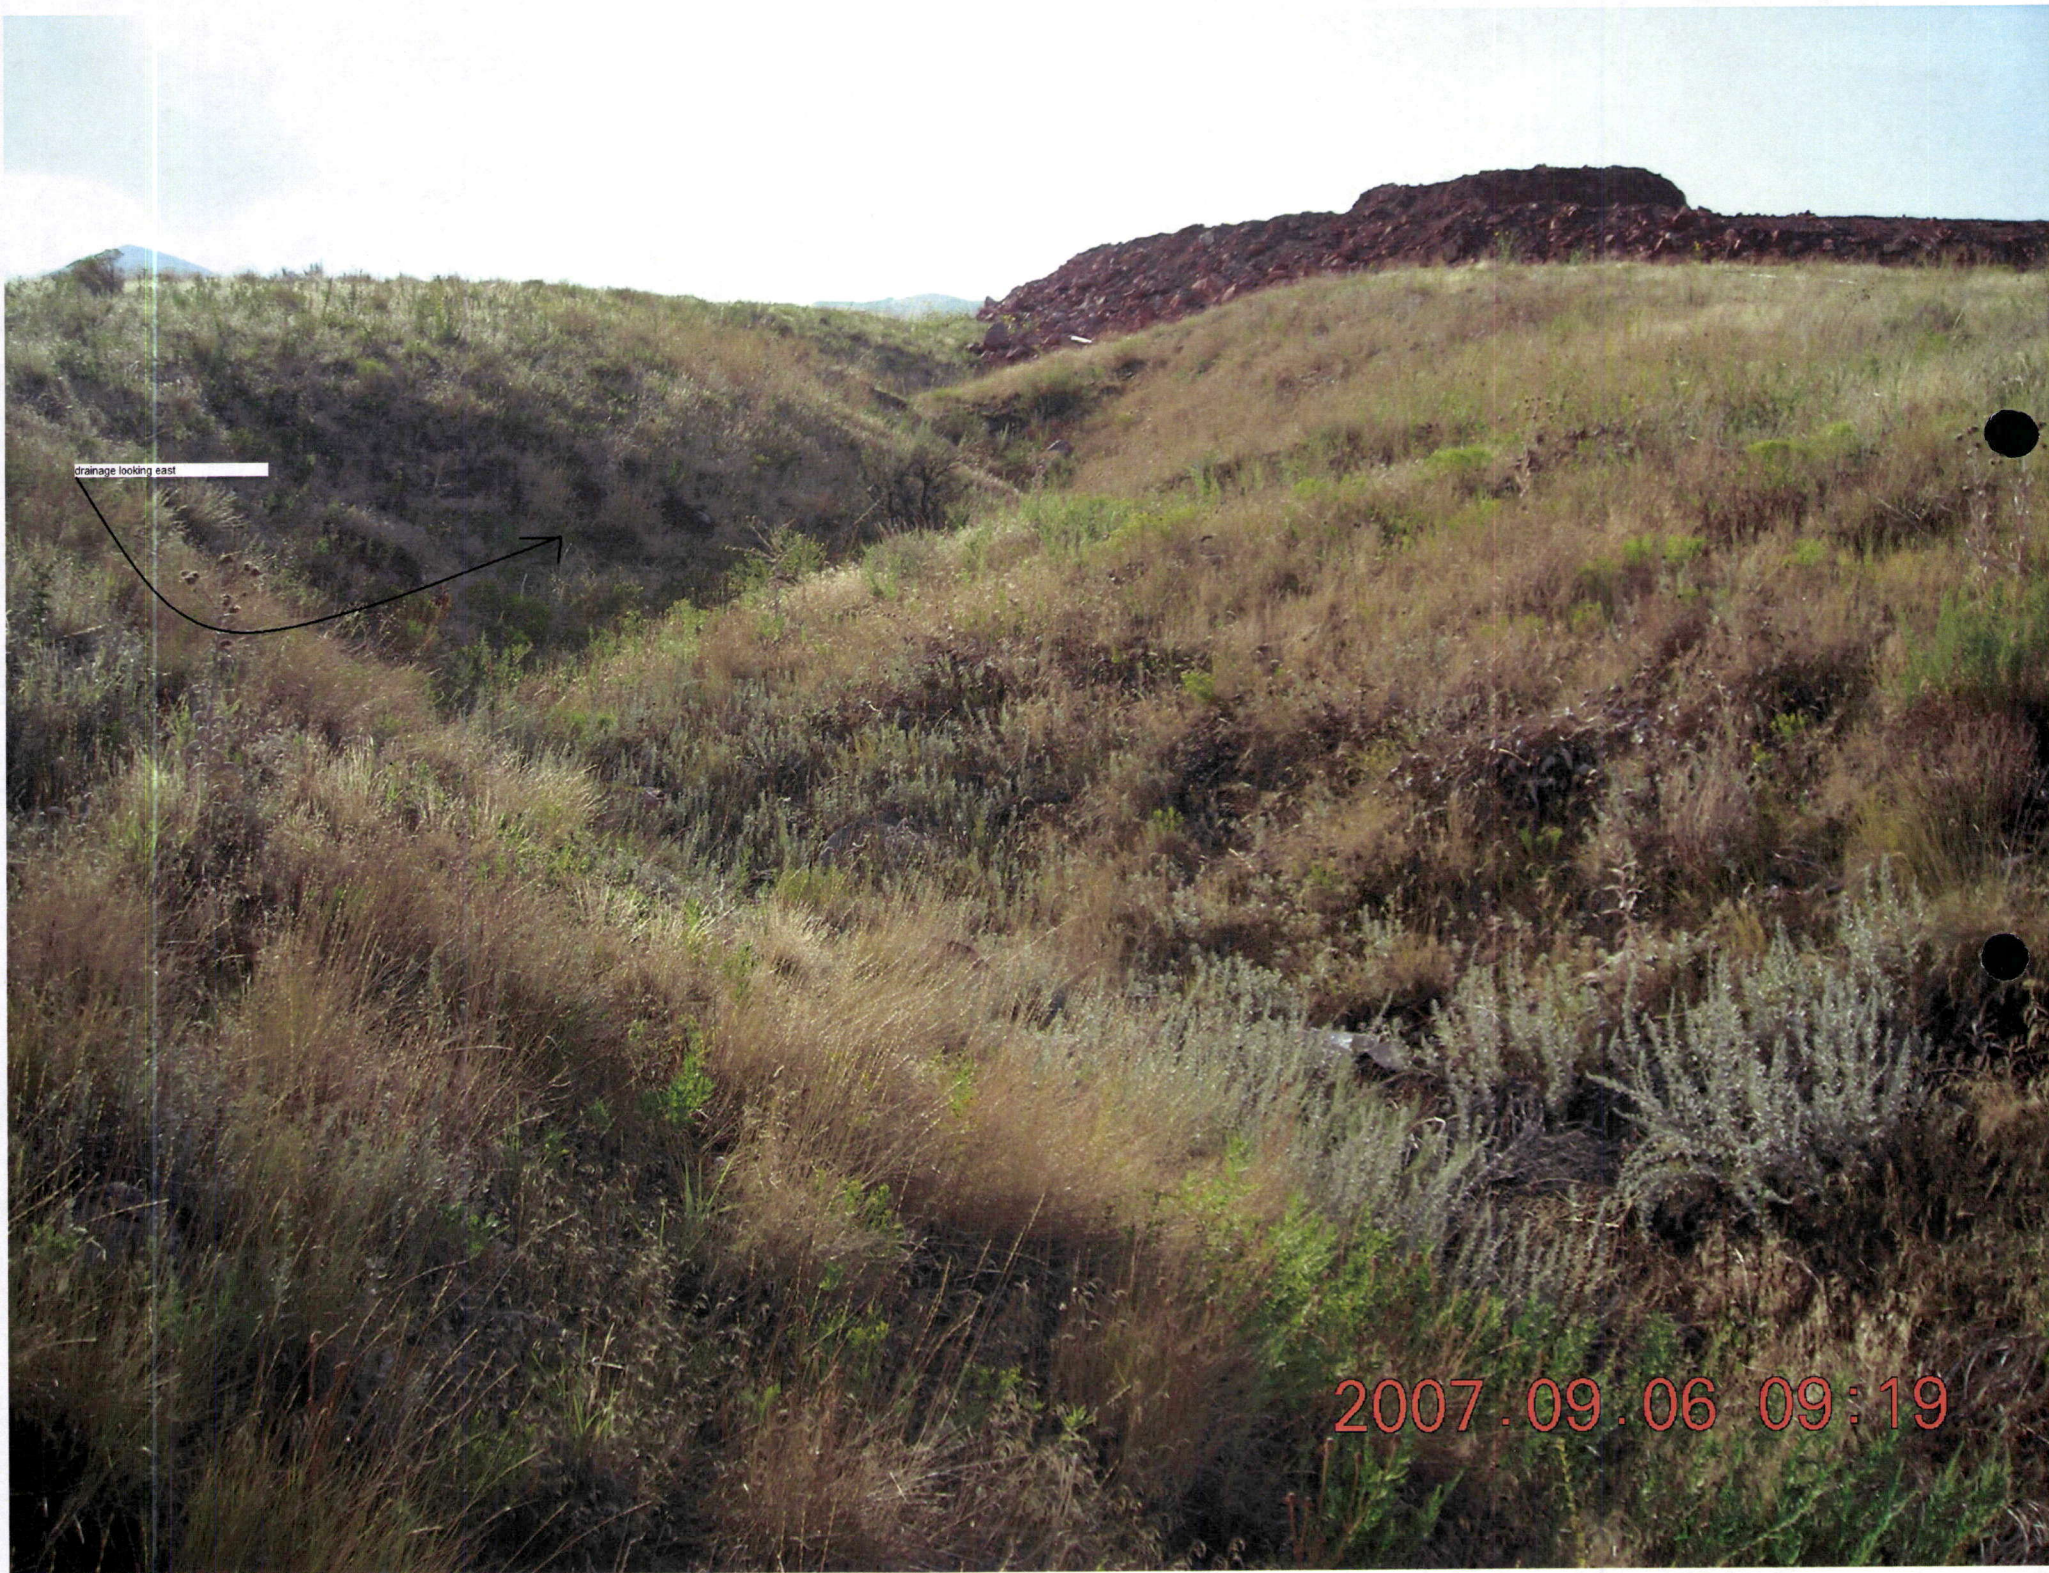
2007.09.06 09:19

drainage looking east

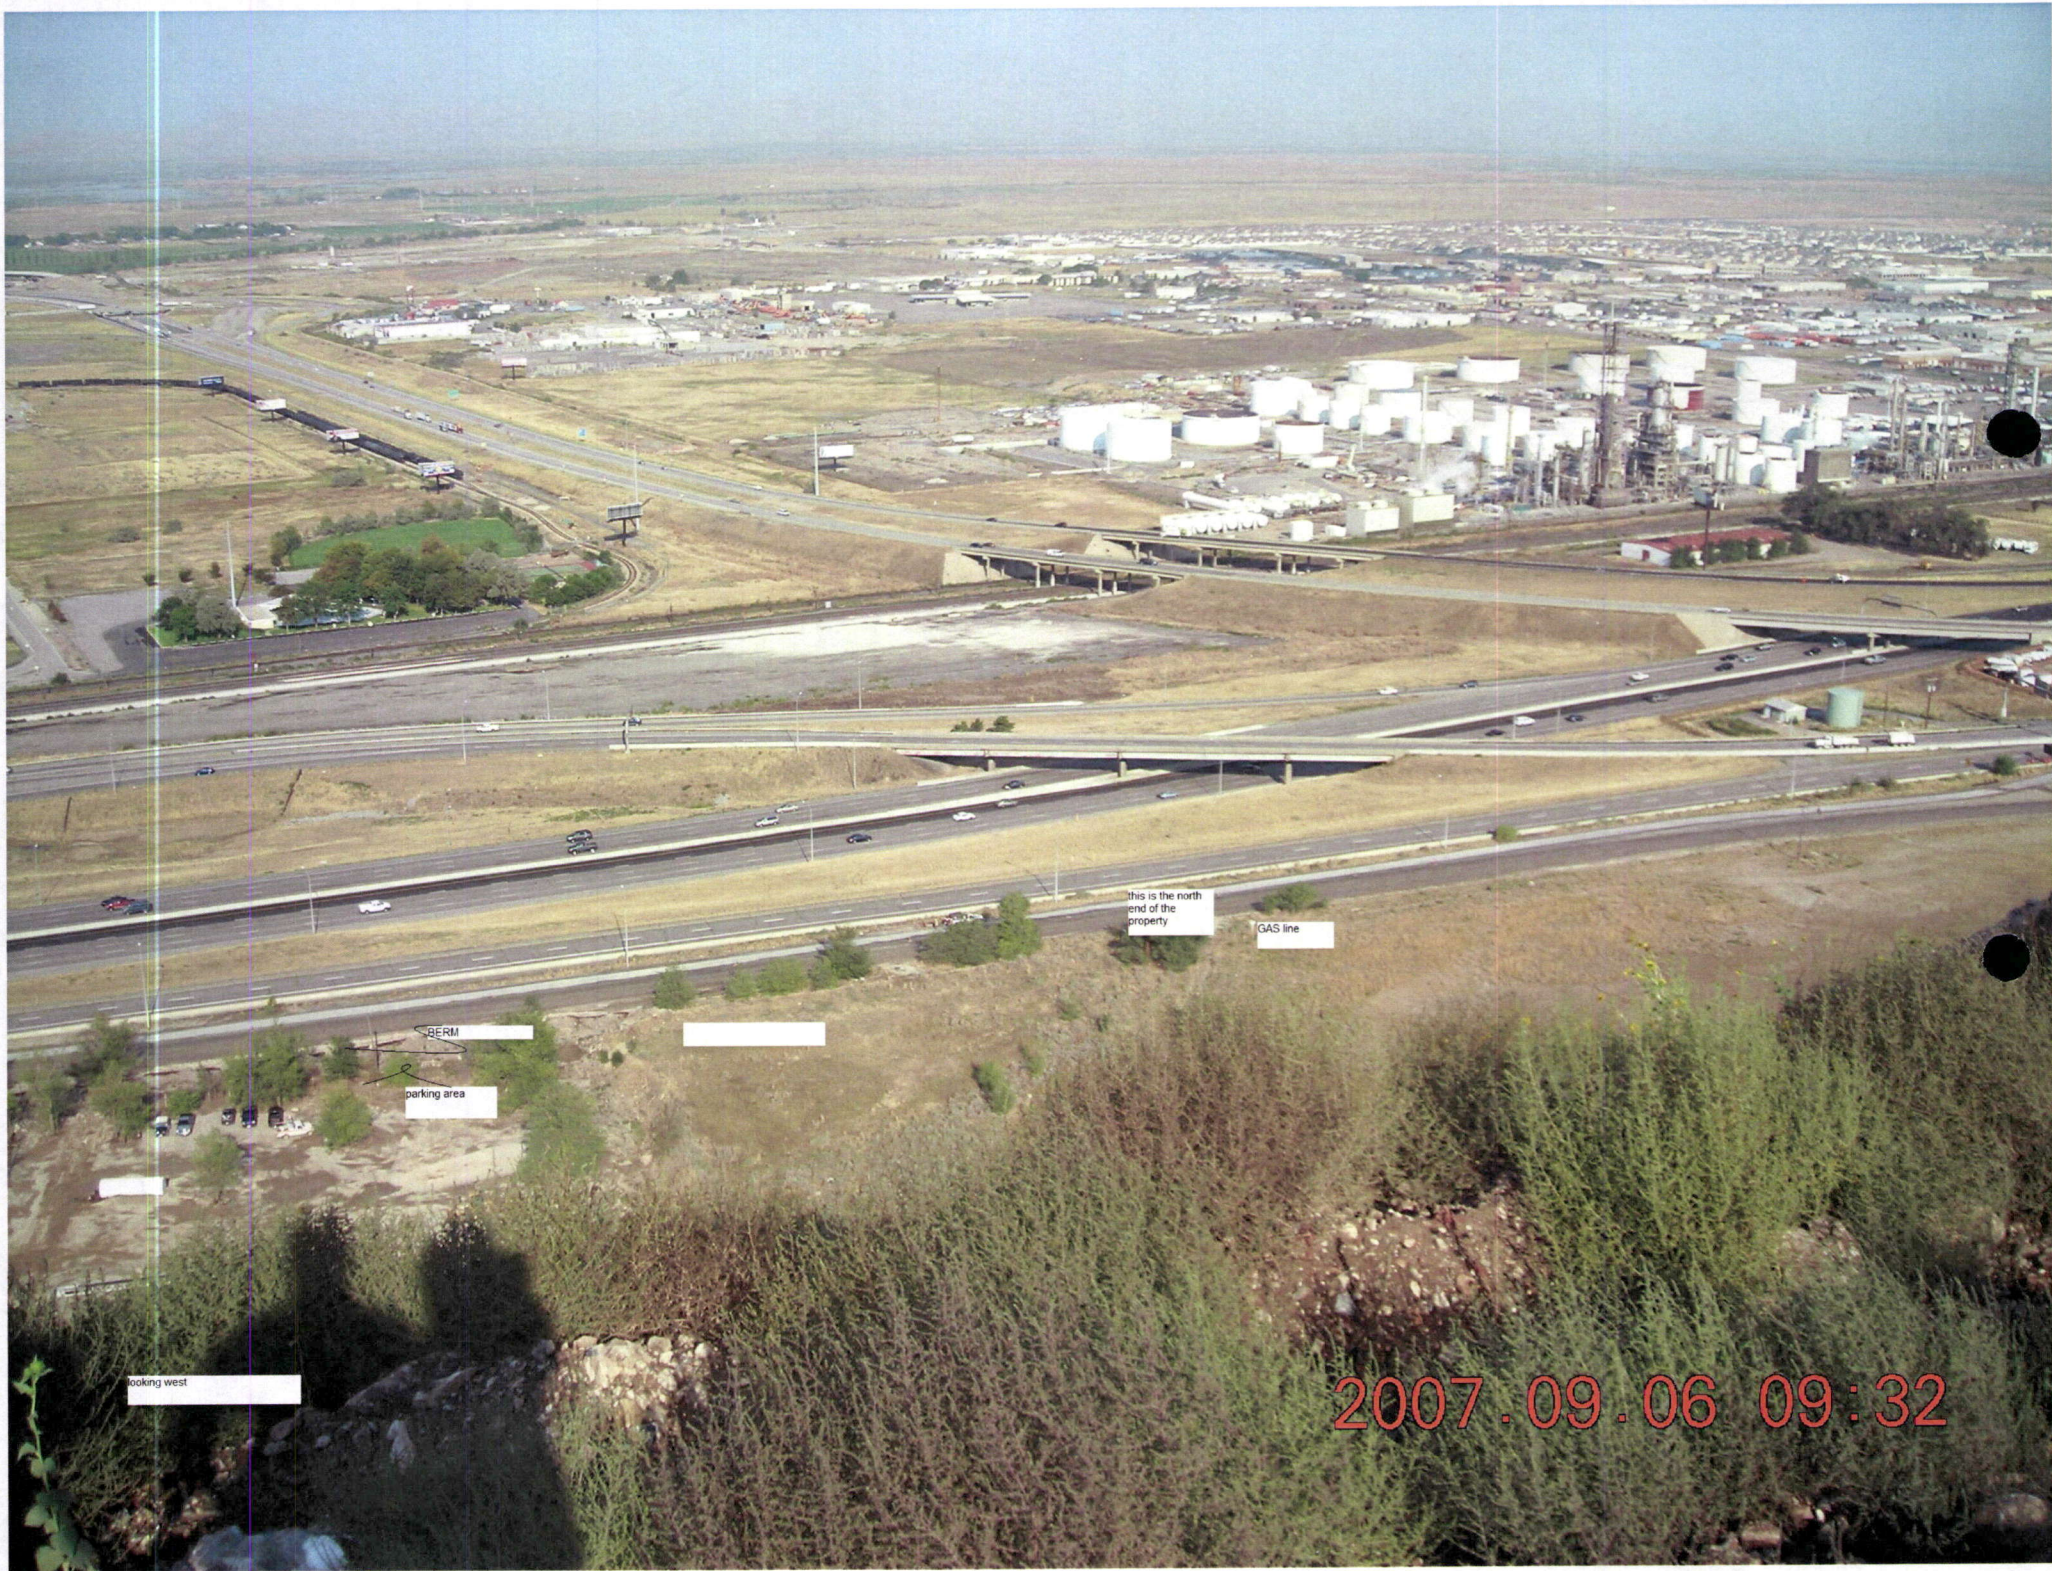
2007.09.06 09:32

looking west

BERM

parking area

this is the north
end of the
property

GAS line

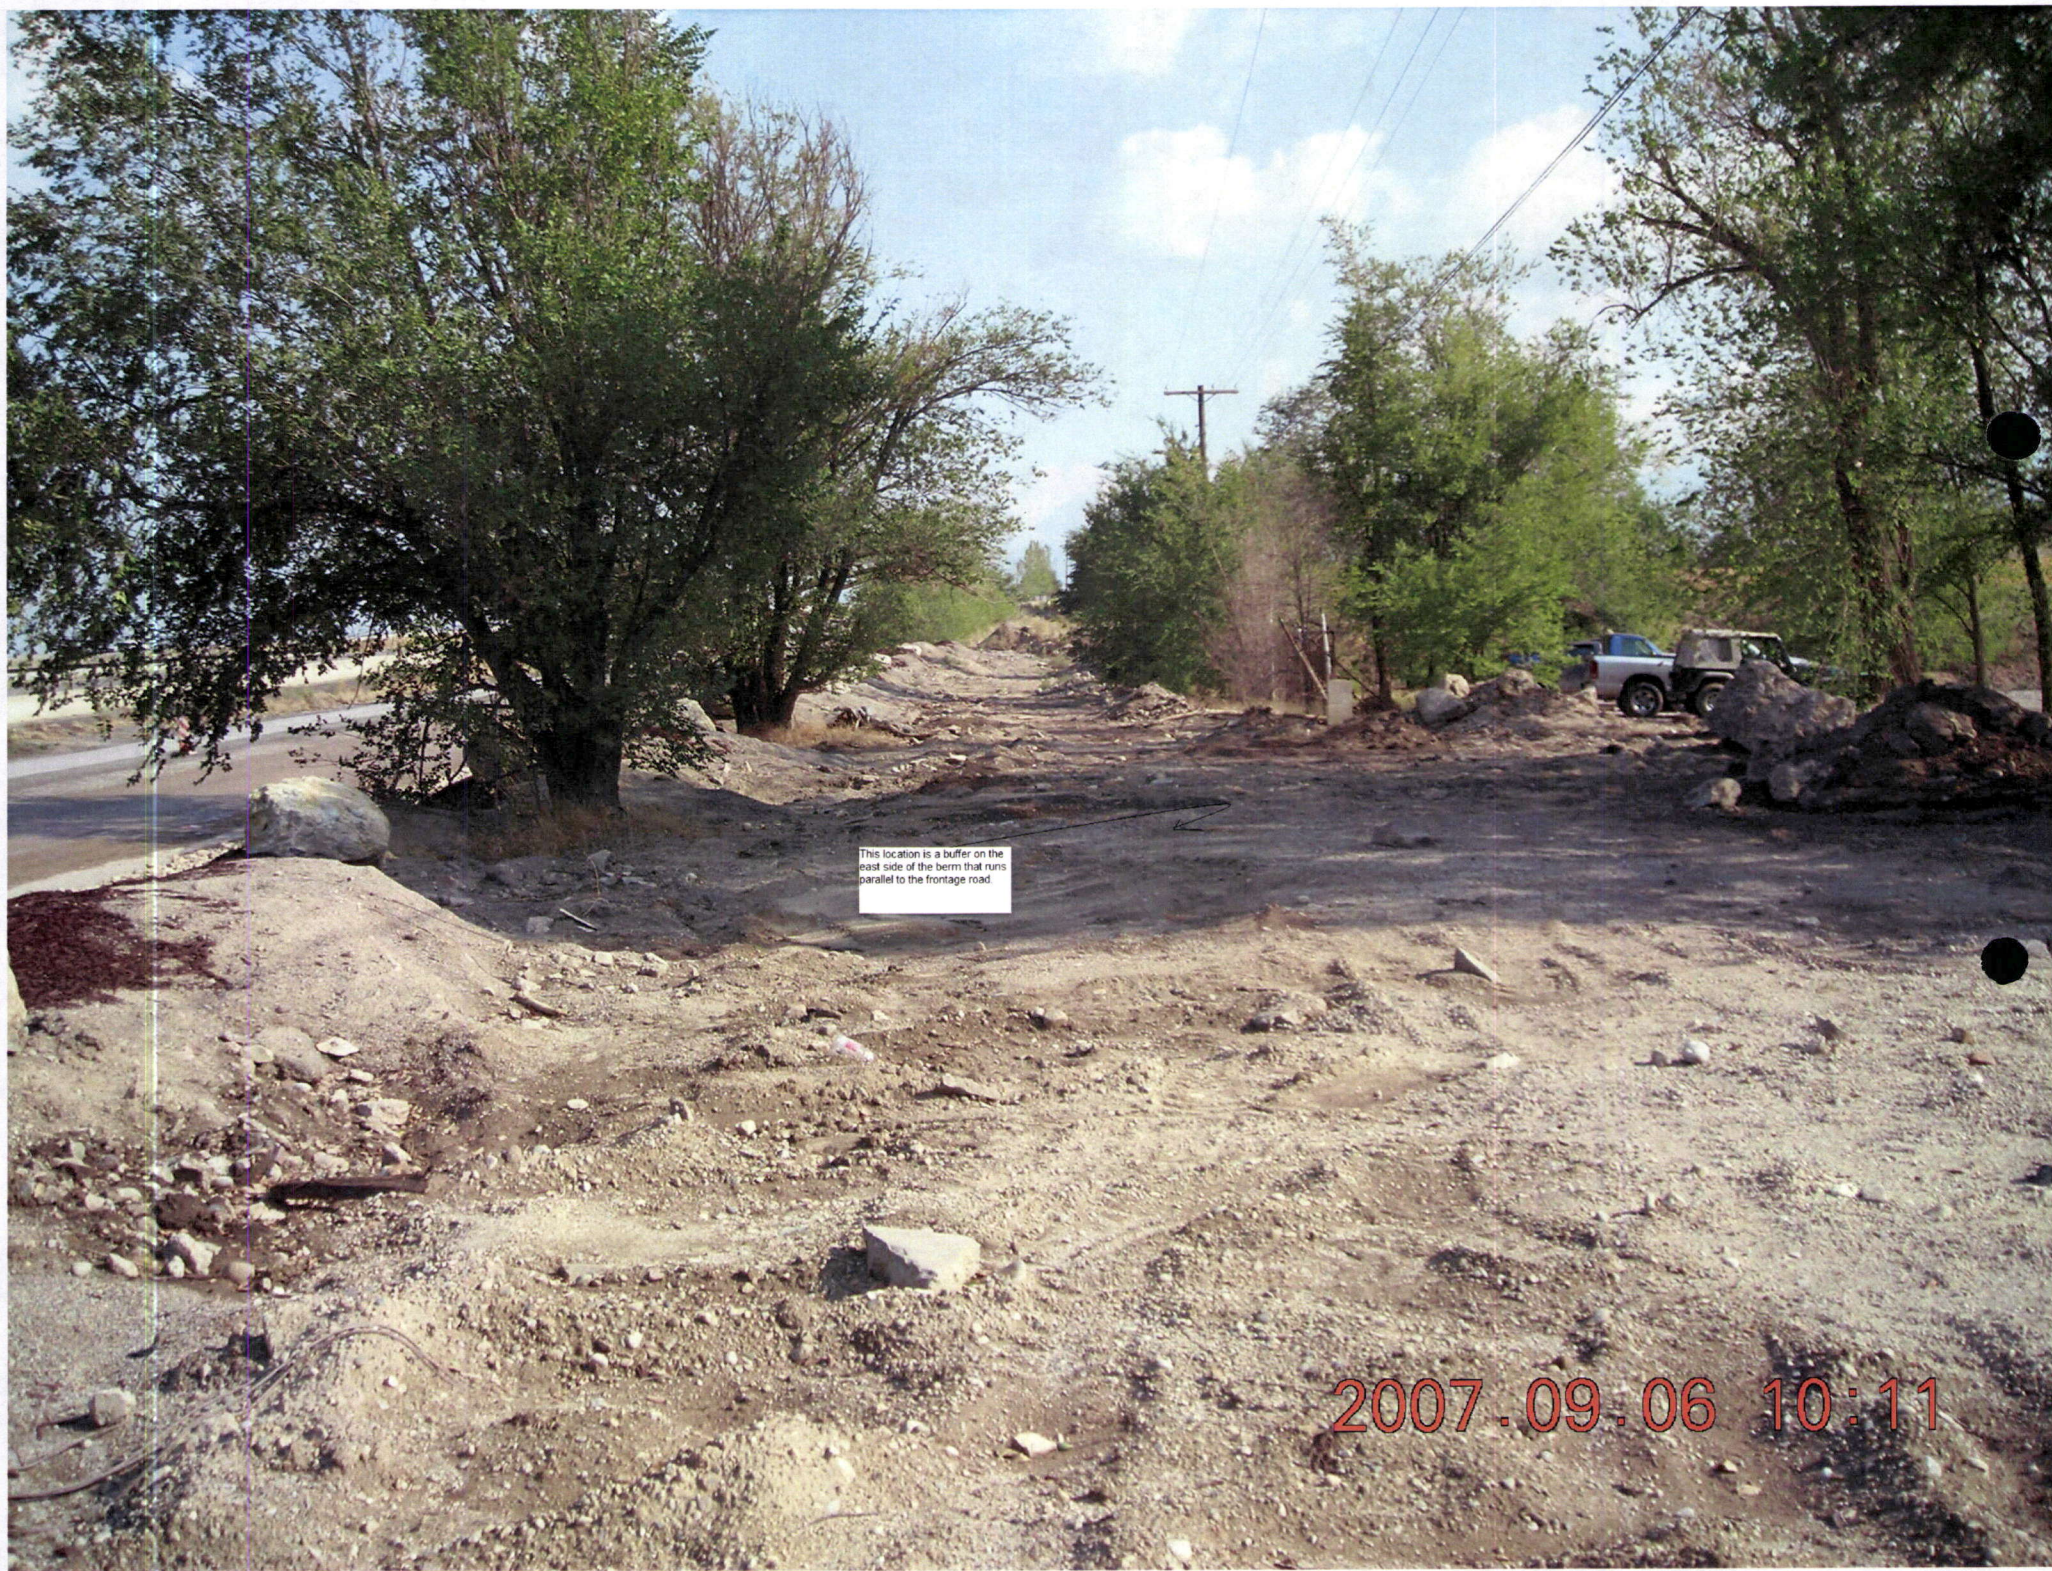
2007.09.06 10:11

The berm on the west side of the property is in excellent condition. Just north of the scale house entrance there is a buffer area that is also well maintained and an excellent idea. They have removed the junk (from prior land user) from the area and clean up efforts appear to have been very good.

This location is a buffer on the east side of the berm that runs parallel to the frontage road.

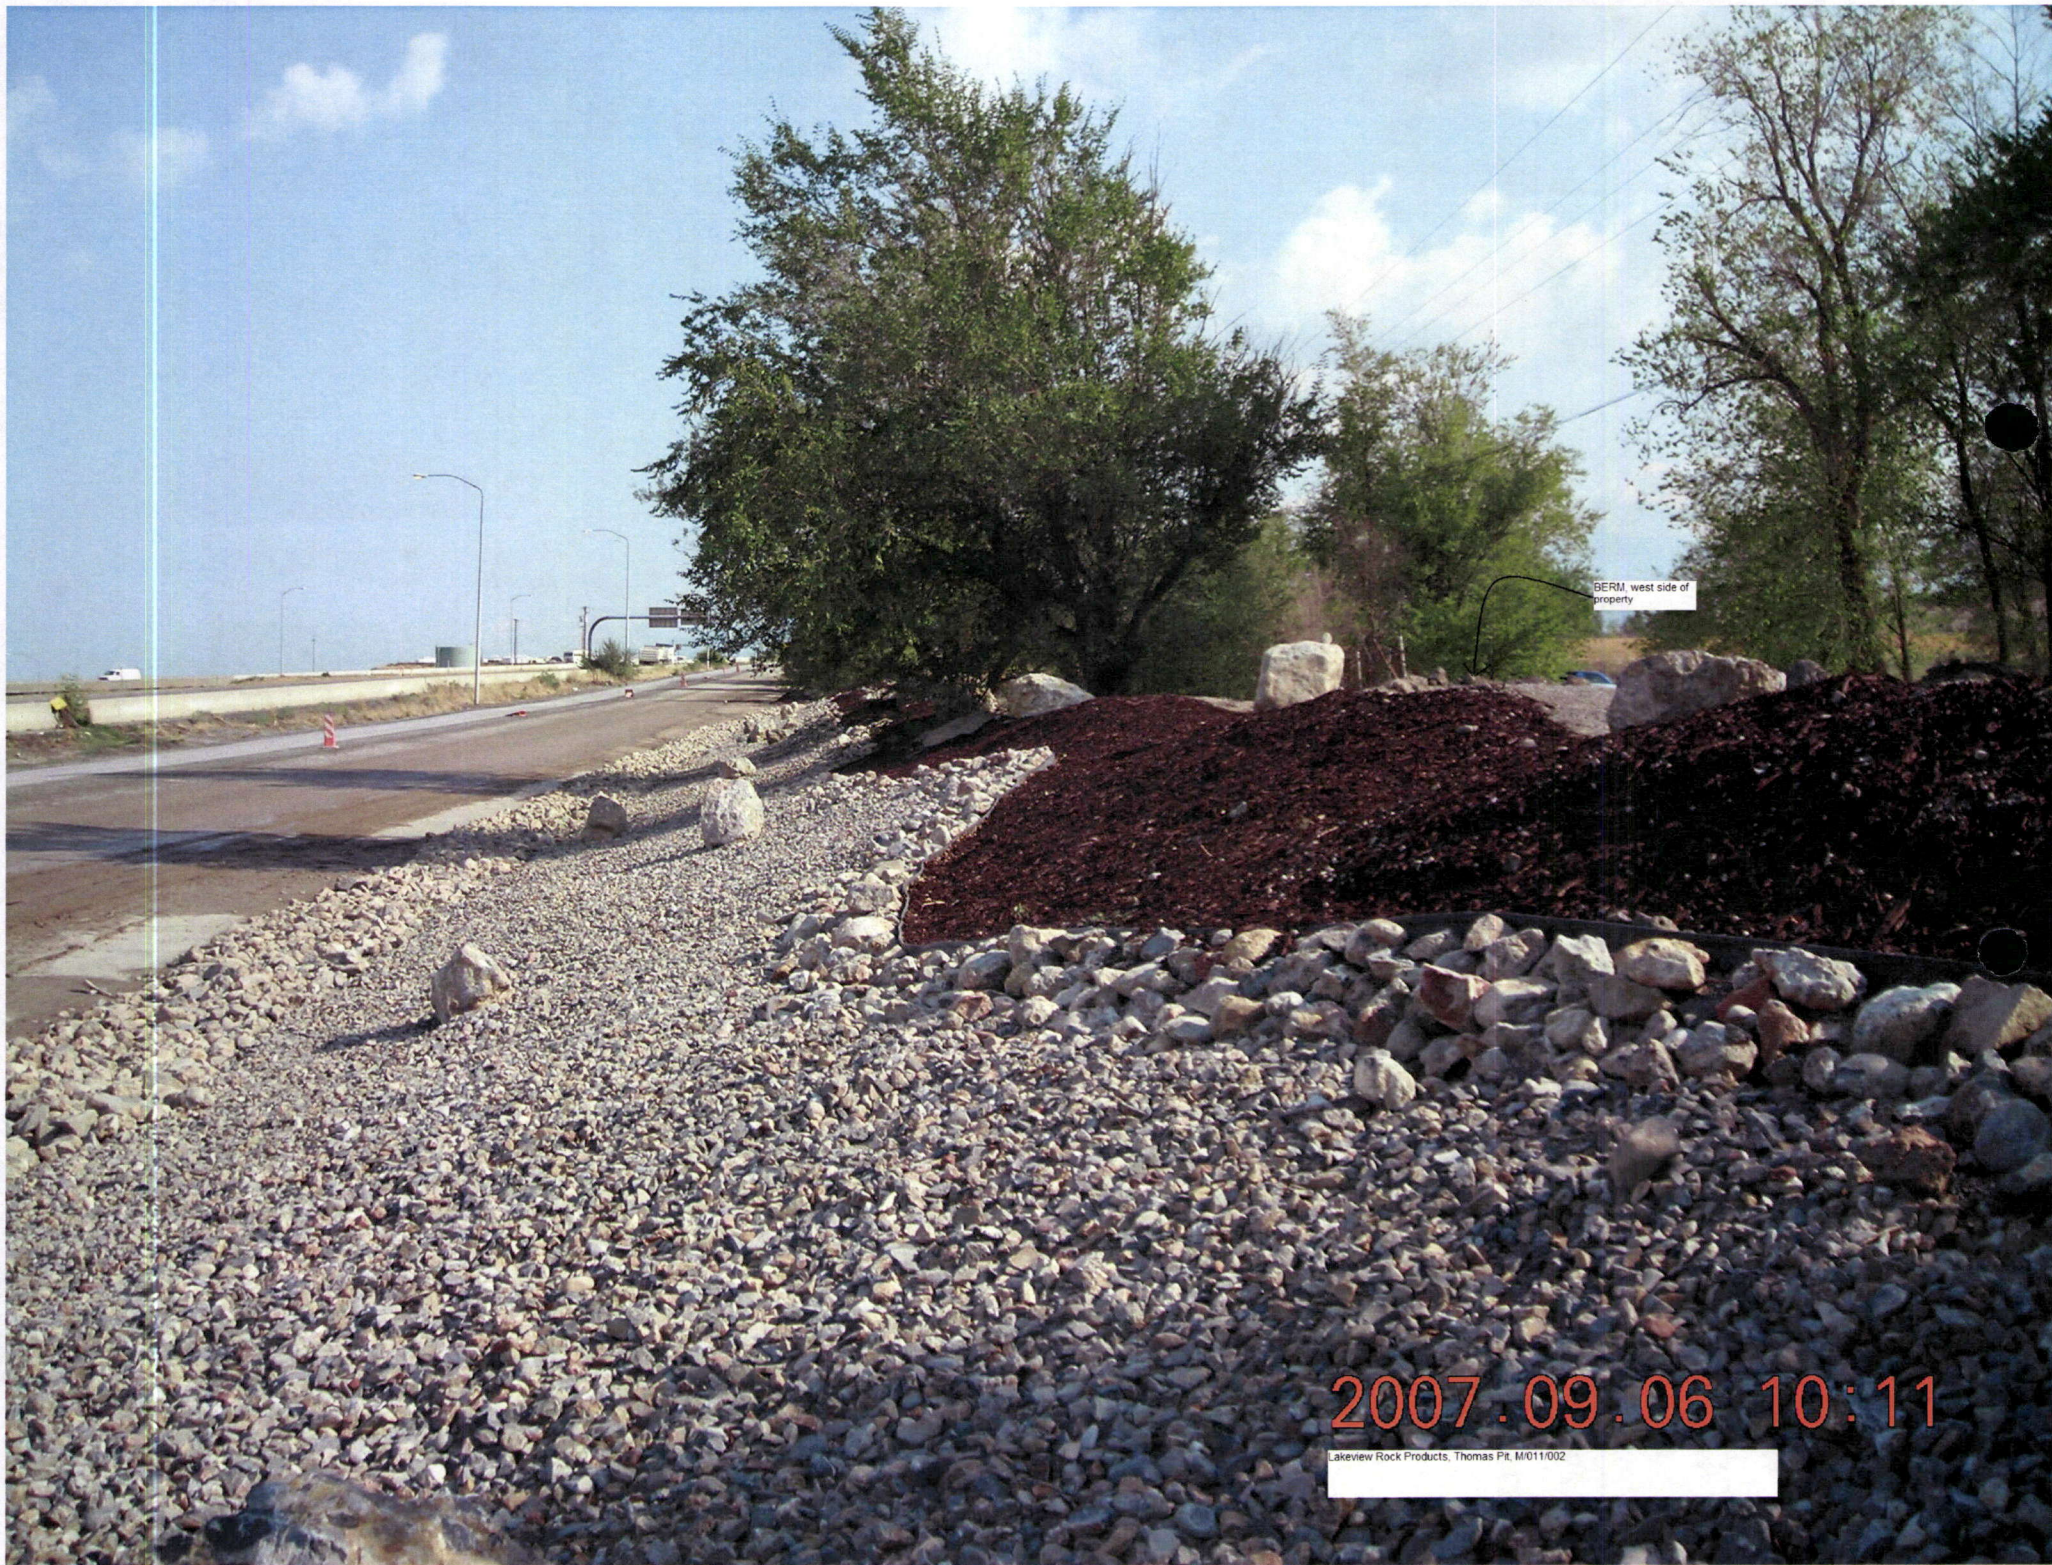
2007.09.06 10:11

BERM, west side of property

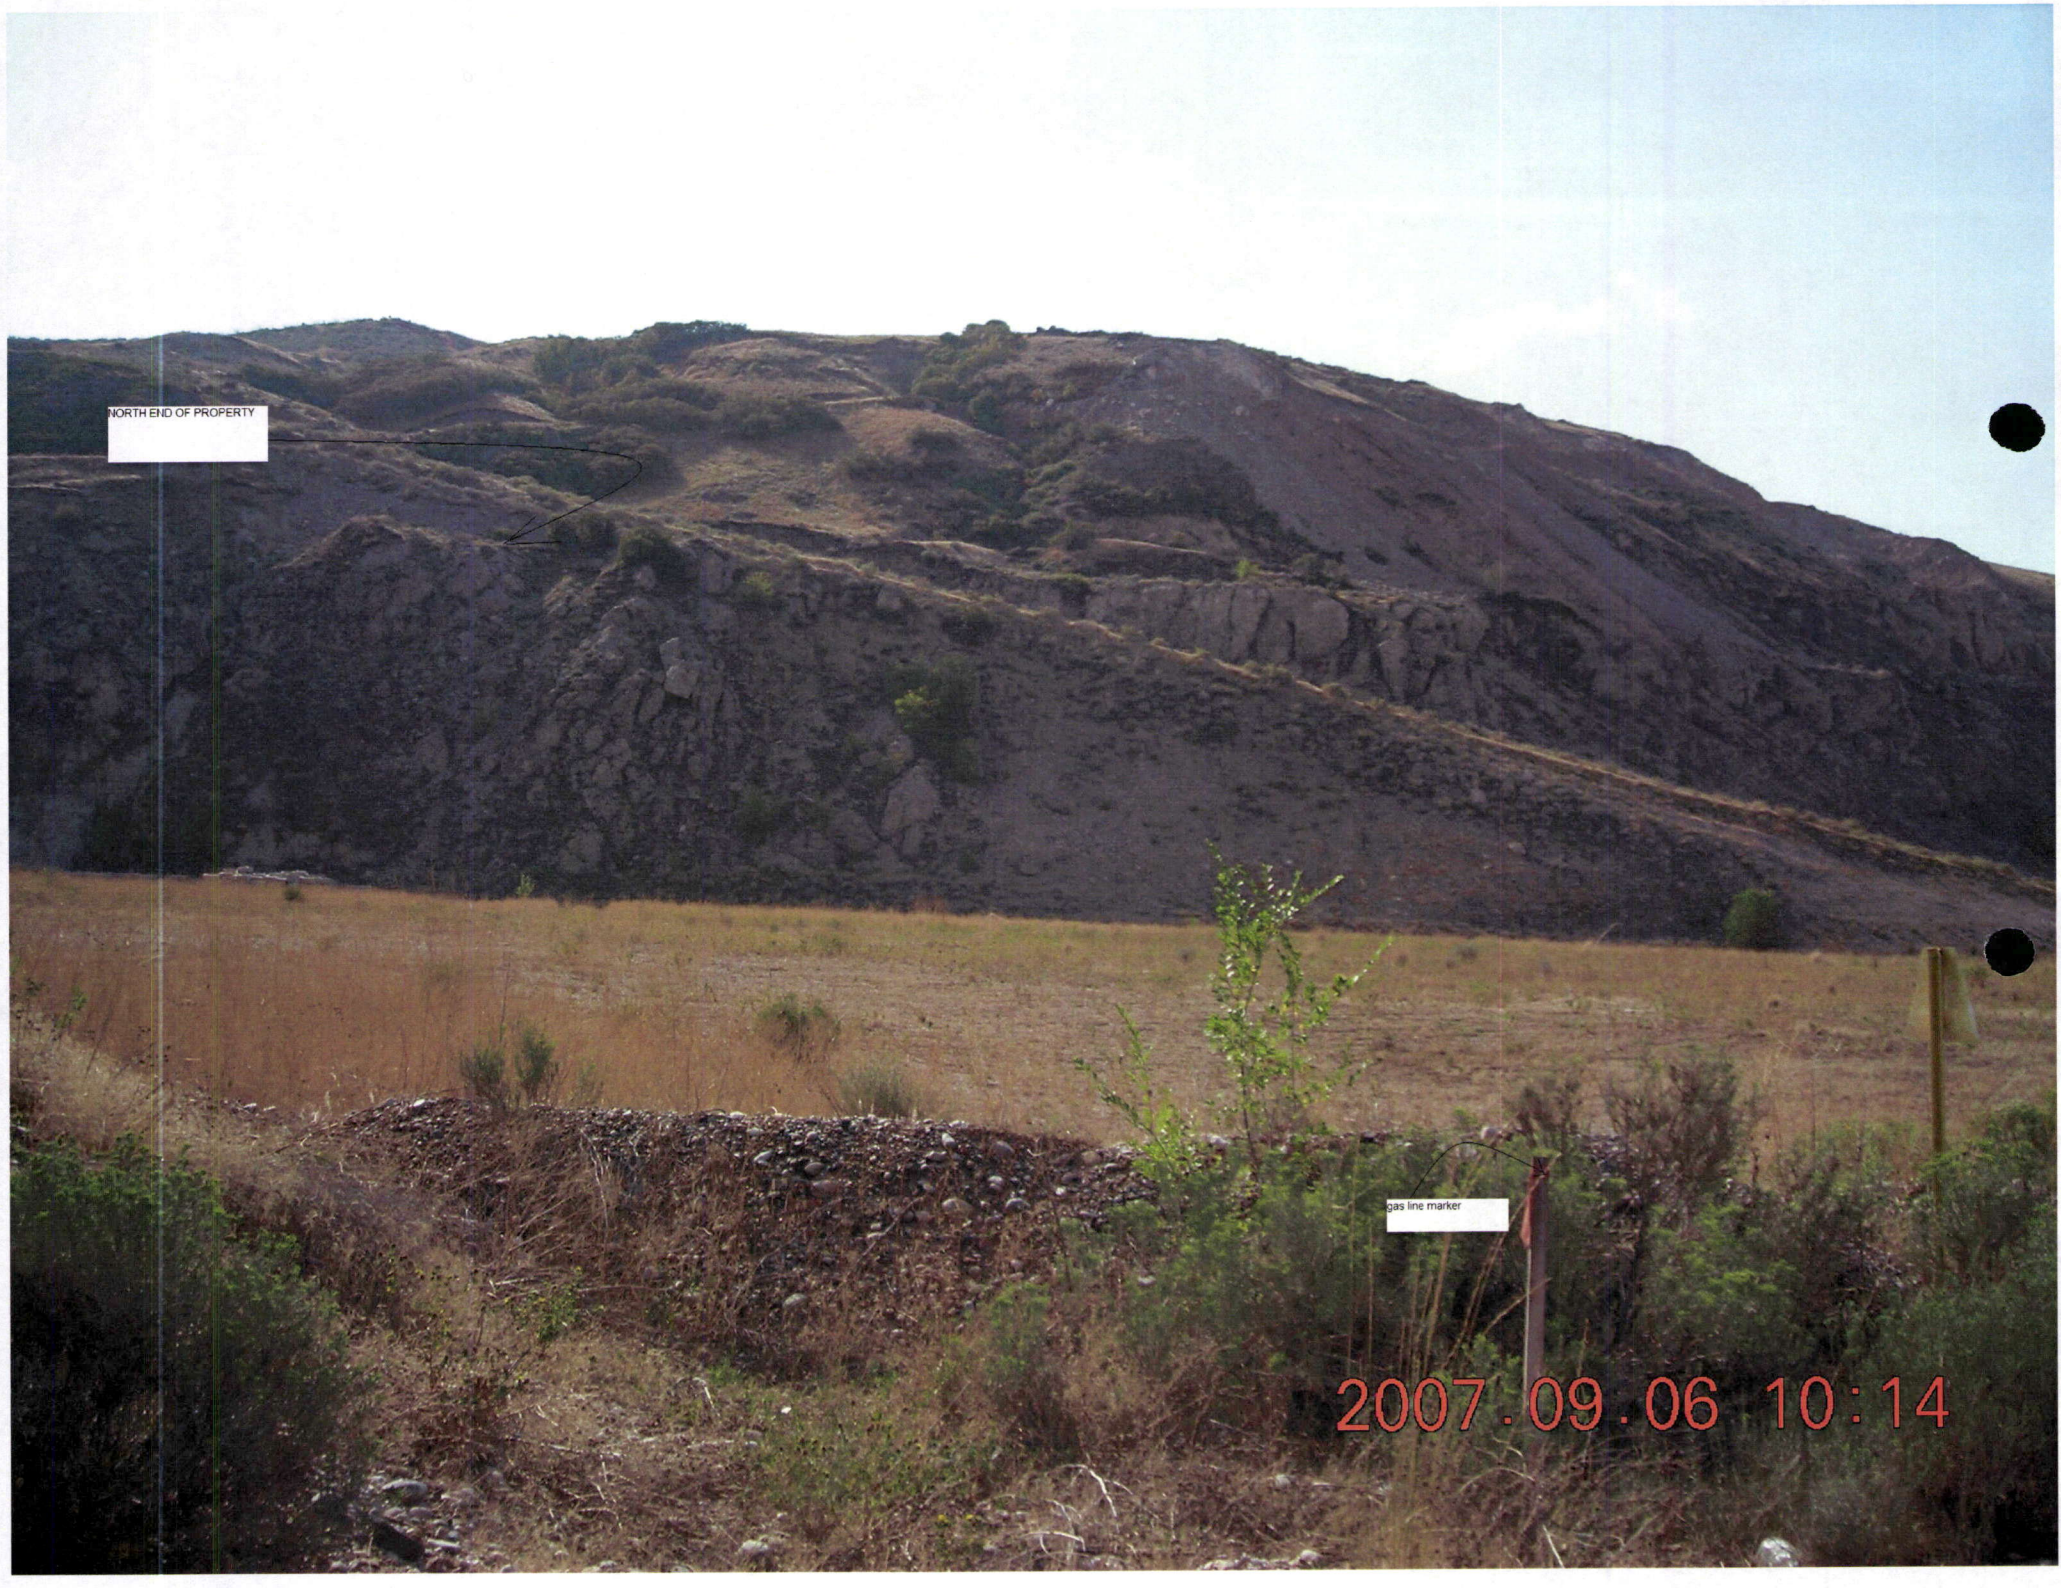
2007.09.06 10:14

NORTH END OF PROPERTY

gas line marker
